Beth Itzchock Cemetery Cleaning and Preservation Project

Beth Itzchock Cemetery
Ashley, McIntosh County, North Dakota

In June 2014, Rebecca and Stuart Kauffman requested information about the preservation of the Beth Itzchock Cemetery in McIntosh County, North Dakota. The cemetery is located at N 46.07831 and W - 99.37872. north of Ashley, North Dakota (Figure 1). After reviewing digital photographs in possession of Mr. Kauffman, my wife and I saw the potential of saving three and potentially four grave markers. We negotiated to work on Sunday, August 17, 2014. We departed Minot on Saturday, August 16 and stayed the night in Bismarck and departed for Ashley at 7:00am CST on Sunday. We arrived at the cemetery at 9:10am where we met with Rebecca and her son Lincoln. After an initial assessment, we confirmed three stones for restorative work. Water had been delivered to the site by a local farmer. This reports provides the details of the project.

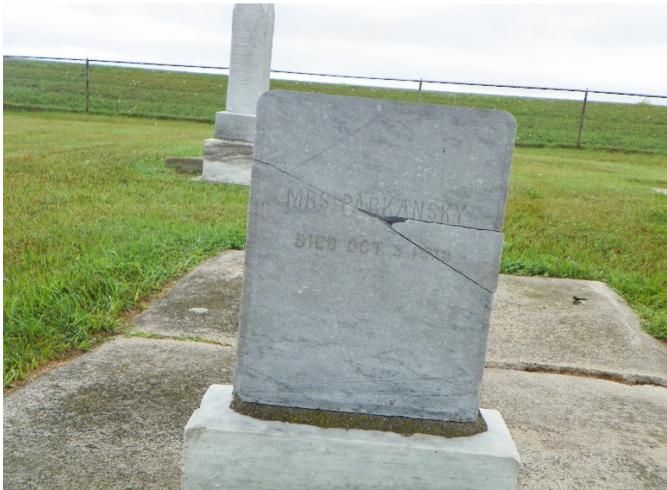
Grave marker one (Parkansky), was broken into three pieces (no loss) and dry fitted in place. It was also not attached to its base.

Figure 3. The Parkansky marker was broken into three dry-filled pieces and was no longer attached to its base.

The stone was dry-fitted together and a previously installed concrete finish between the stone and its base was no longer holding the marker in place.

The pieces were removed from the base and the concrete finish removed by manual means. Once removed the stone surface was cleaned using D/2.

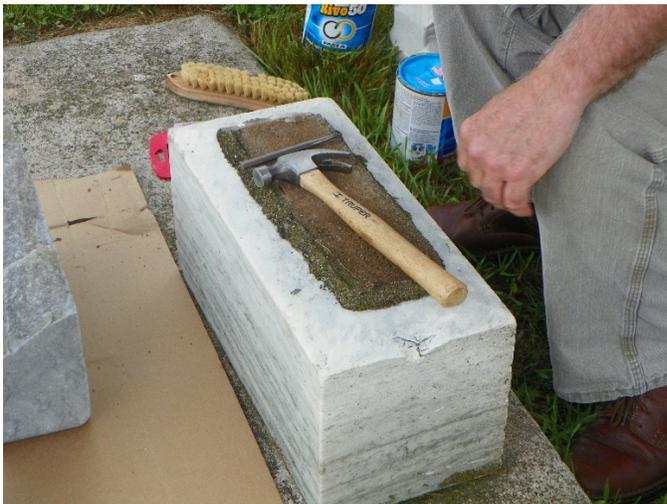
Figure 4. The concrete finish on the Parkansky base prior to removal.

The original pins holes were found beneath the concrete finish still holding the remains of wooden pins, which were removed by drills using a .5 inch mason bit. The holes in the base of the monument were also cleaned and found to be suitable to holding a new, stainless steel pin.

The base was then fastened to lower portion of the monument. Each of the three pieces were then drilled, pinned, and secured using Rivo 50. No overflow occurred and the surface of the marker remained clean. To ensure a smooth set, a frame with clamps was installed to hold the repairs in place, as shown below.

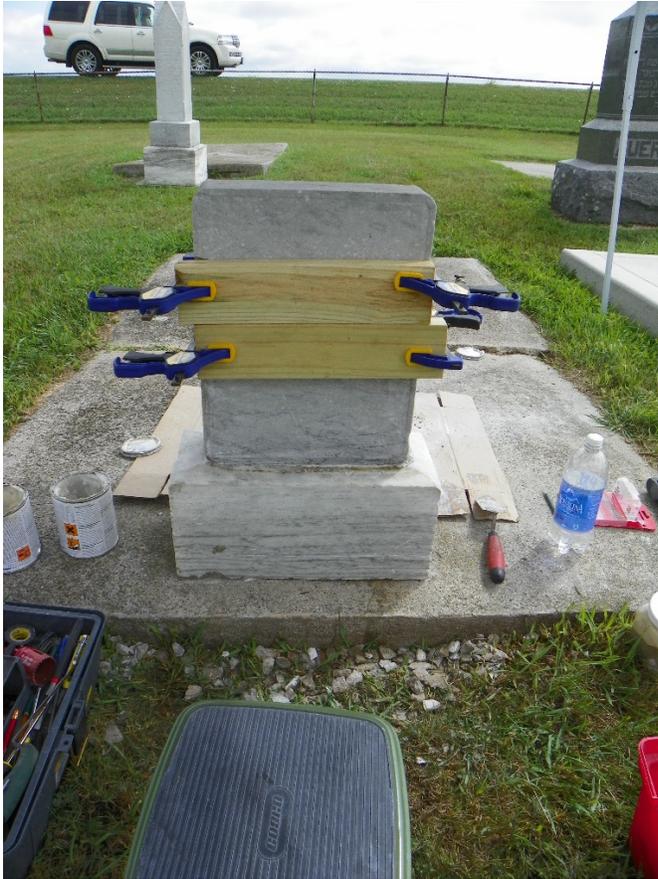
Figure 5. The Parkansky marker in the final stage of repair, culminating a 3.5 hour project.

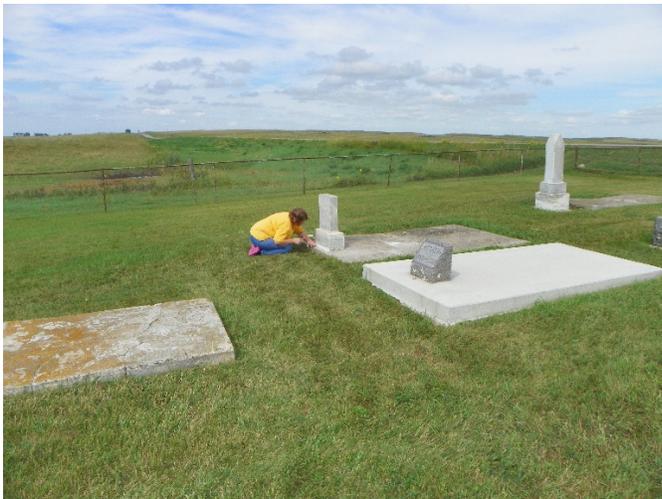
Figure 6. Eunice Timbrook applies Litomex to the seams in the Parkansky monument and base.

The supports remained in place until we completed the third project, after which my wife returned to the marker to complete treatment with Litomex (cracks and seam between base and monument), as shown below.

The Lithomex will darken somewhat this winter providing a better color match.

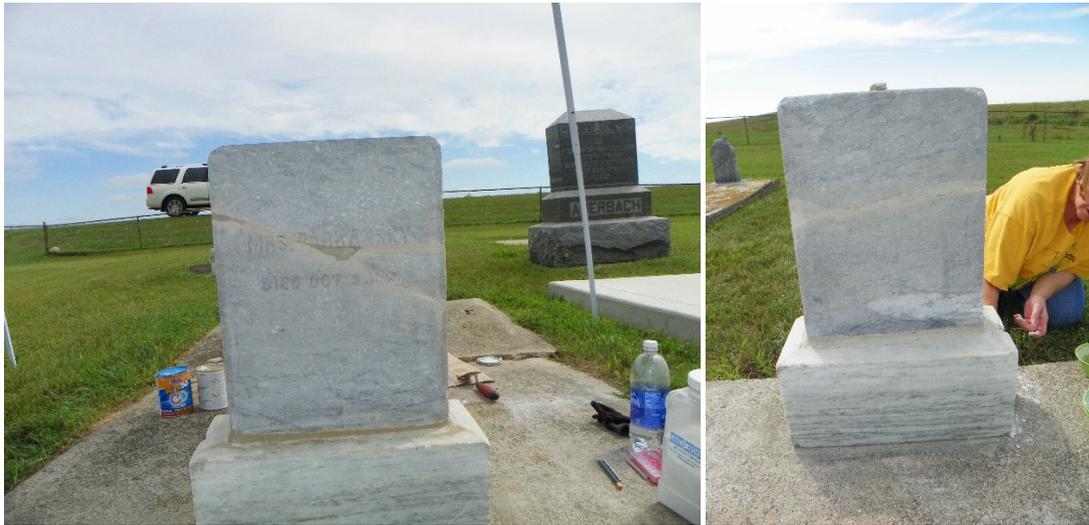
Figure 7. The Parkansky marker after Lithomex application (front and rear. The center was still damp and had not dried yet. Humidity on site averaged 80% affecting dry time for both Lithomex and Rivo 50.

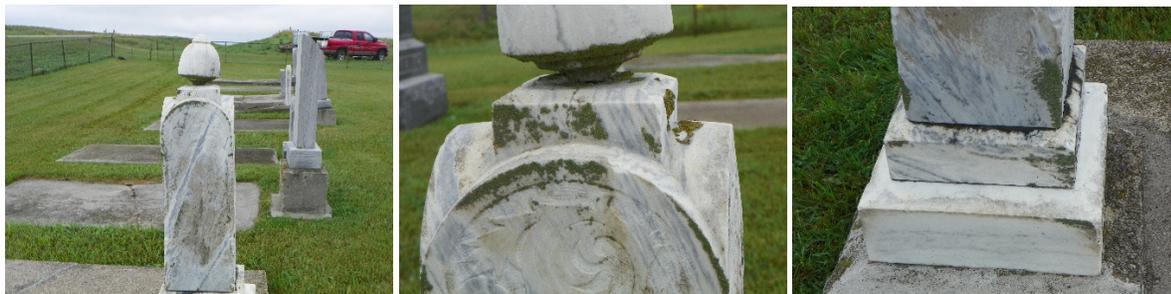
Grave marker two (Kiva Bender) required cleaning and the monument decoration was no longer attached (potential loss or destruction).

The Kiva Bender marker had minor biological growth, but was safe for cleaning. The marble decoration atop the monument was also loose.

Figure 8. Bender monuments showed biological growth and a loose decoration atop the pedestal.

The monument was cleaned by my wife, Rebecca, and her son, Lincoln using D/2 Biological Solution. After cleaning was completed and the stone dried, the damaged support for the decoration was repaired using Lithomex, after which the cleaned decoration was resealed using Rivo 50, as shown below.

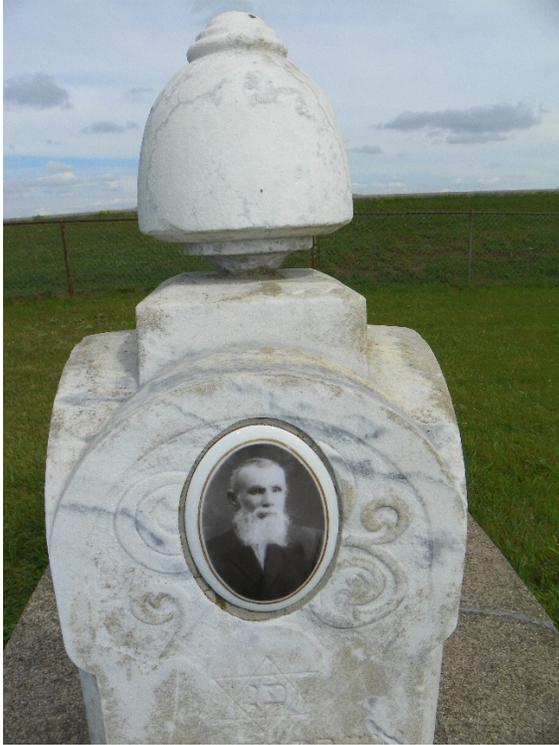
Figure 9. The repaired decoration atop the Bender monument.

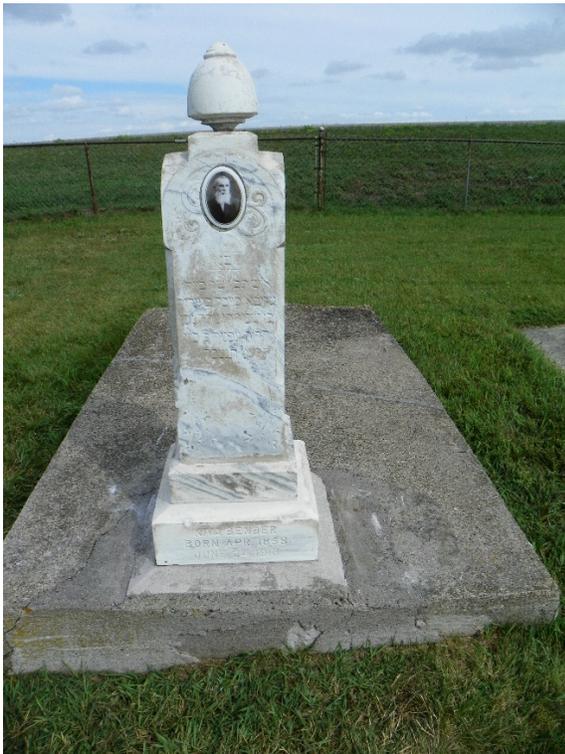
Figure 10. The Bender marker following cleaning and repair.

The monument will continue to whiten over time.

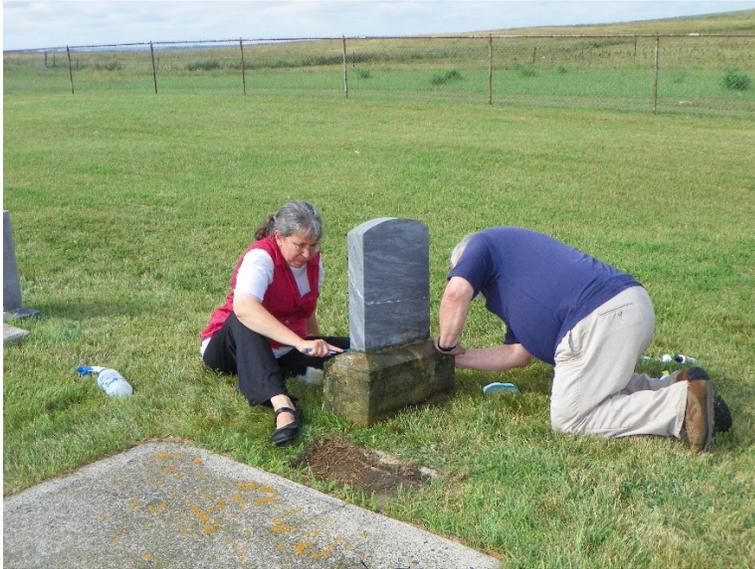
Grave marker three (Benjamin Reuben), required leveling and the monument attached to its base.

The Benjamin Reuben marker was the last monument to be treated. The Reuben marker was tilting beyond 15 degrees and was no longer fastened to its base. It was removed from the base, and the base removed

Figure 11. Rebecca and volunteer Raymond Schneider-Kuhn (Bath, SD) clean the Reuben marker.

from the ground by shovel and leveled. Like the Parkansky marker, existing pin holes were in excellent shape, preventing the need for drilling.

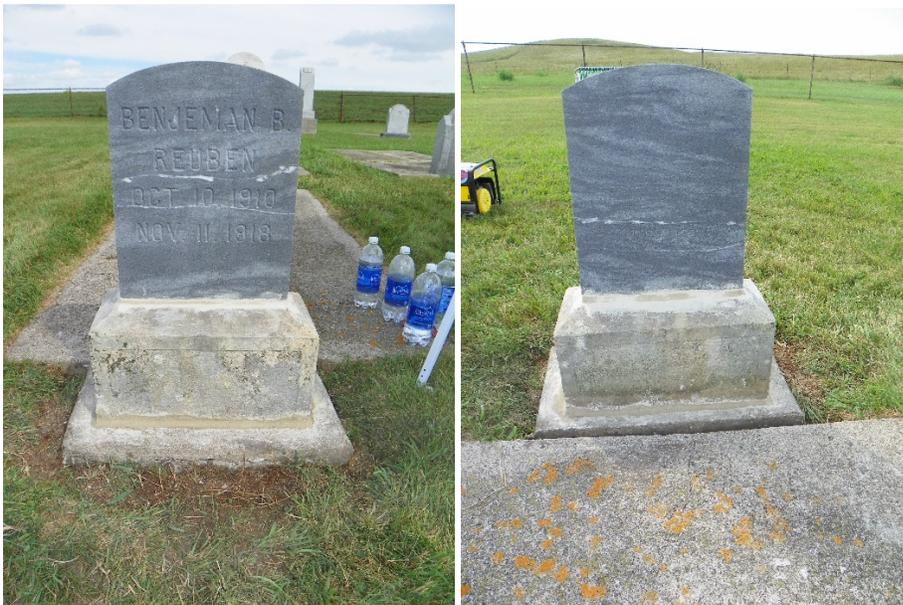
Figure 12. Front and rear of completed Reuben marker.

Once the base was leveled, the monument was fitted over the newly install stainless steel pins and secured with Riva 50. Lithomex was then installed around the monument base.

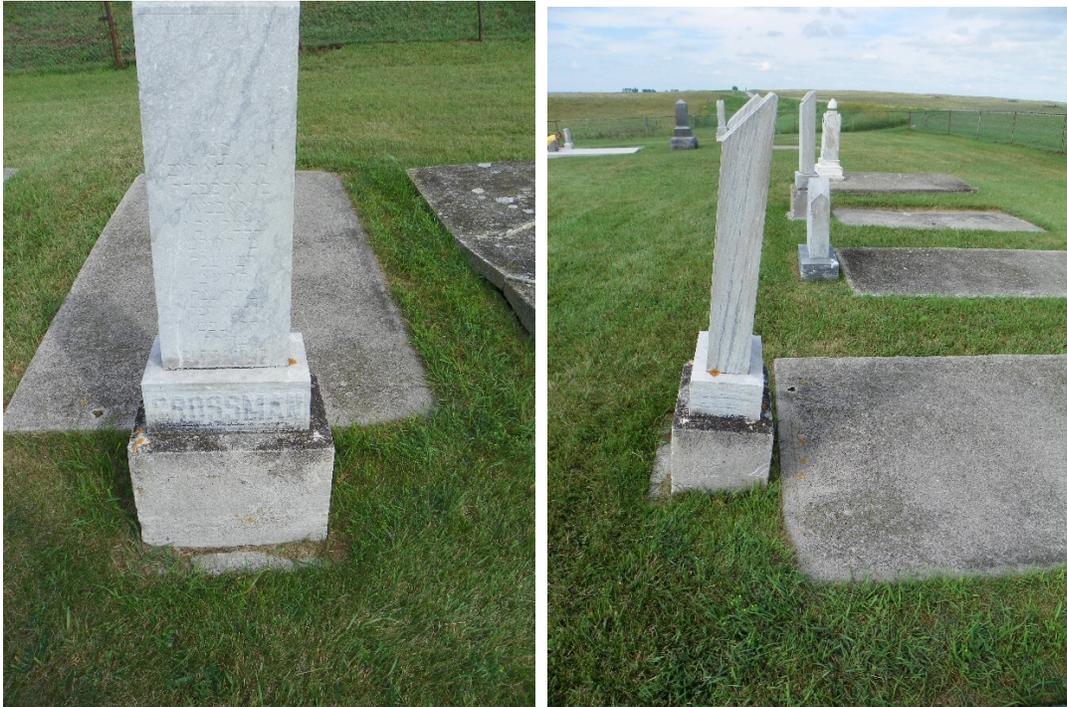
One other grave marker (Grossman) is past the 15° angle of decline and requires leveling. The stone is also loose from the base and represents a SERIOUS safety risk. The leveling should be managed with a hoist and

Figure 13. The Grossman marker is a high risk stone posing **SERIOUS risk of death or injury.**

appropriate lifting hose due to the weight and size of the stone. This should be undertaken by a professional monument company or mason.

1. The Grossman monument is loose from the base and while it has not reached the 15 degree threshold, the size and weight of this maker makes it a high risk stone posing a **SERIOUS** risk on death or injury. The monument should be braced this winter with 2.4 studs and supports driven into the ground until professional repair can be completed.

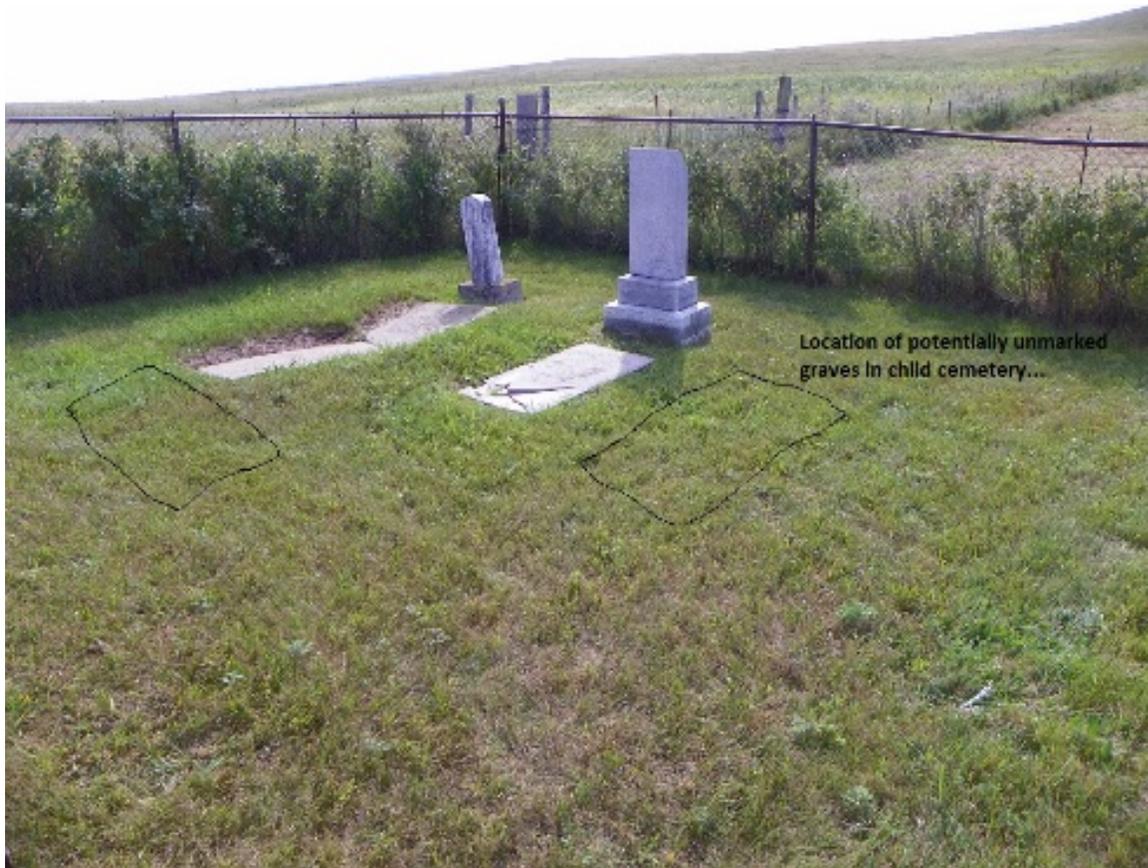
Figure 14. Child cemetery and potential site of several unmarked graves.

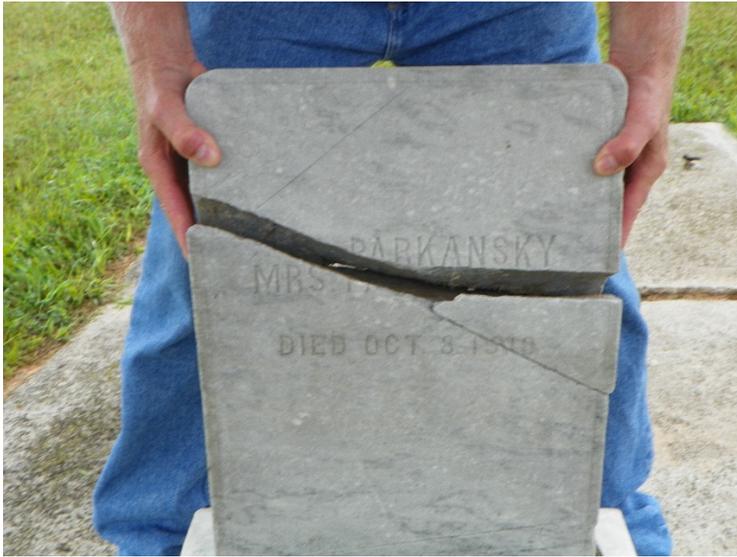
Figure 15. Extent of damage to Parkansky marker.

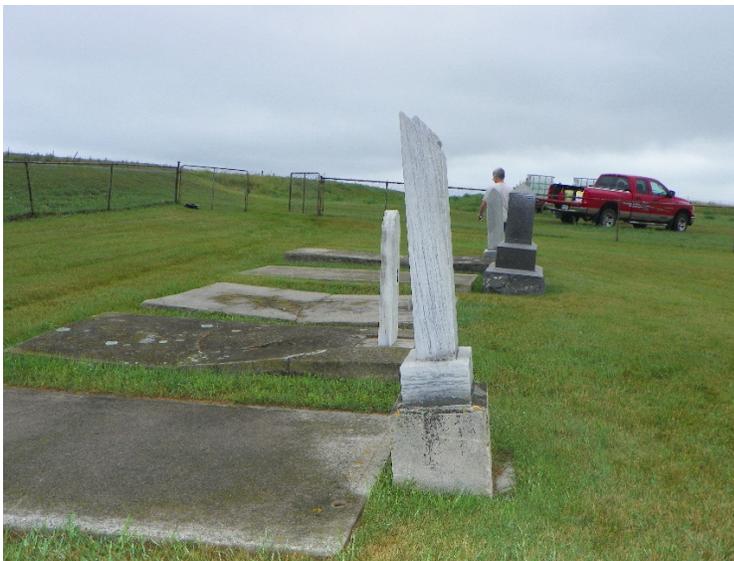
Figure 16. The Grossman marker poses a **SERIOUS** risk of injury or death.

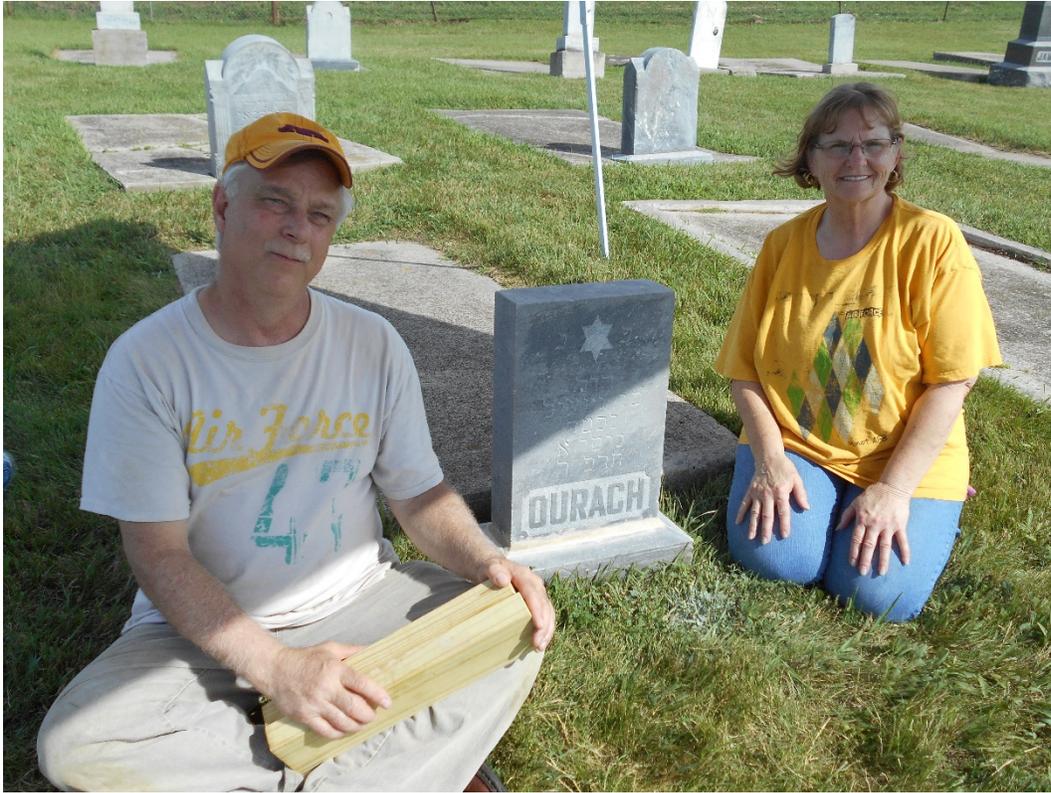
Figure 21. We finished the day by using Lithomex on the base of the Ourack stone. We cleaned up the work site and headed for home. A good day's work.
